MERRIMACK RIVER BASIN
WESTMINSTER, MASSACHUSETTS

MEETINGHOUSE POND DAM
MA 01018

PHASE I INSPECTION REPORT
NATIONAL DAM INSPECTION PROGRAM

NOVEMBER 1978

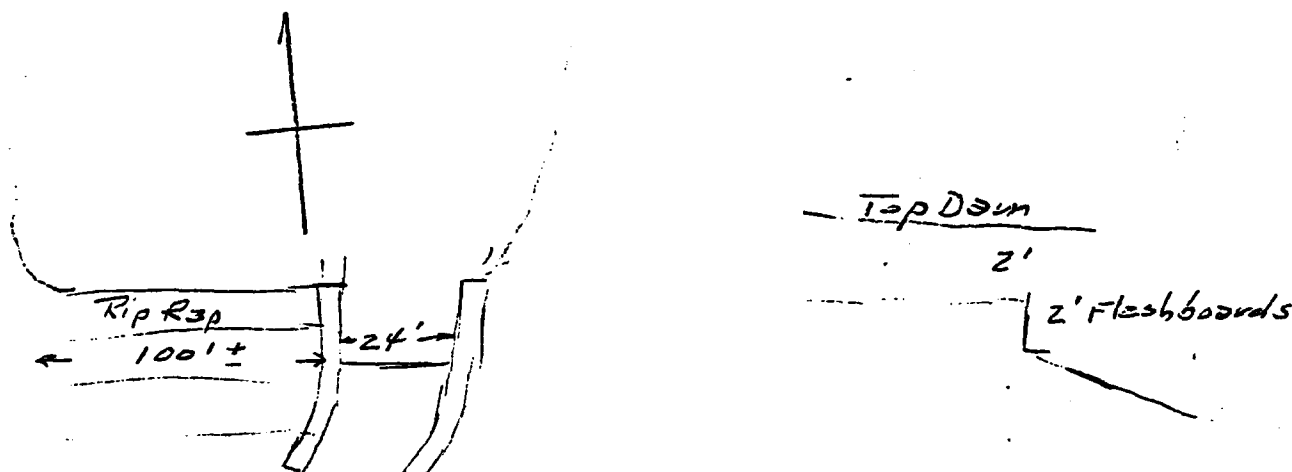
Sketch (Not to Scale):

Rip rapped earth dam with gunited stone spillway 24' wide
2' of boards in place + stone walls are 2' additional feet higher
No gate at this location

* Brush on dam should be cut
